## Case Study

## Eliminating Weld Porosity

### The Challenge

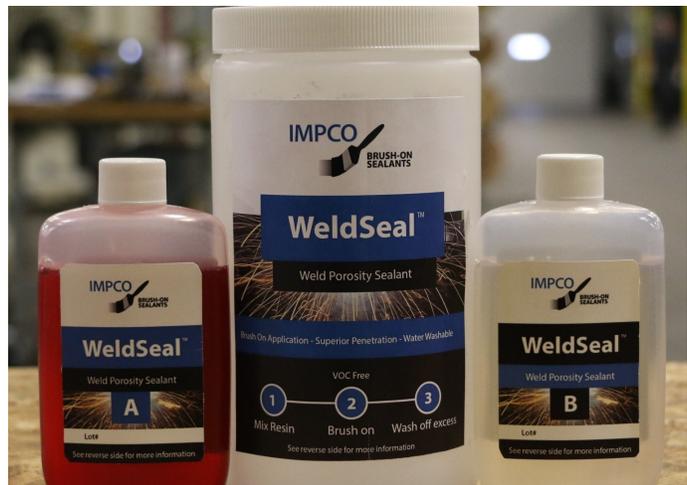
One of the unique features of a Bonnot Extruder is a hollow screw which facilitates additional process temperature control through a re-circulating liquid. Although the screw was pressure tested as part of a standardized ISO quality procedure, a leak of the liquid medium was discovered upon installation at a customer site. The leak, most likely caused by some impact, was isolated to a weld near the exit end of the screw.

Godfrey & Wing determined that the vacuum impregnation process, including use of our Impco Weld Seal Brush-On Sealant, would be the fastest and most effective way to seal the part. [Impco products](#) allow for sealing of aluminum & steel castings, weldments, and macro porosity. WeldSeal is designed specifically to seal iron and steel weldments. The very low viscosity enables it to wick into welds to properly seal any porosity.

1. Discovered the leak location by applying pressure inside the part. The part was submerged in soap and water so that any bubbling would reveal leakage.
2. Cleaned the outside surface to avoid any contamination during the impregnation step.
3. Connected the part to a vacuum pump to remove the air.
4. Applied WeldSeal on the part.
5. Released the vacuum to ensure that the applied sealant remained in the pore.
6. After the sealant cured, we applied overpressure from the inside. The leak was confirmed sealed since no bubbles appeared during the pressure test.
